# Rivershore Estates and Golf Links

## Links Division Report – April 2018

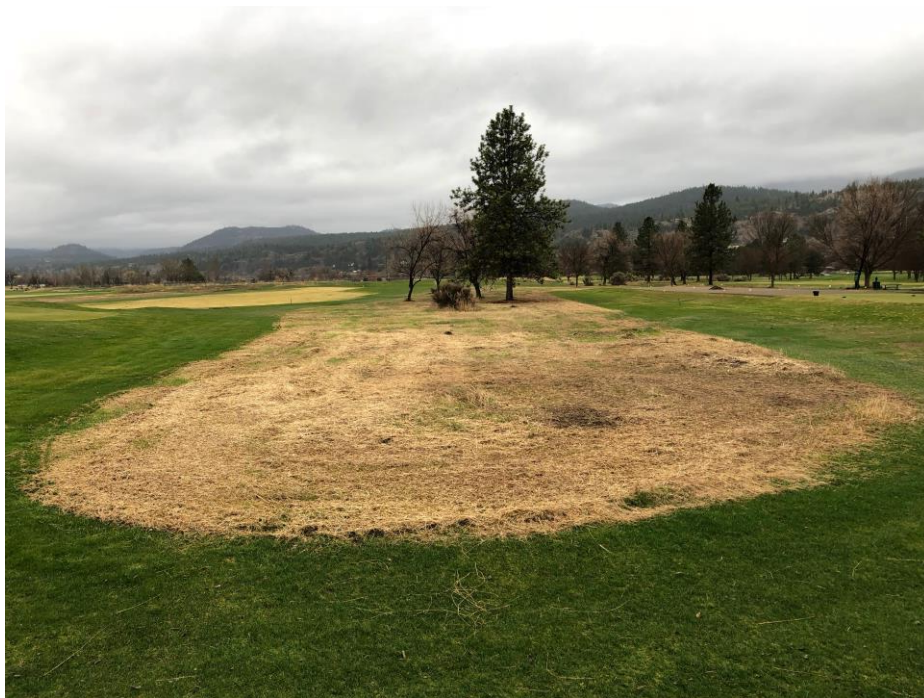
- We have started our seasonal mowing of the naturalized areas. By mowing these areas once a year first thing in the spring we hope to discourage the growth of broadleaf weeds. The grasses in these areas will tolerate the mowing much better than the broadleaf weeds and will hopefully gain a competitive advantage heading into the growing season.

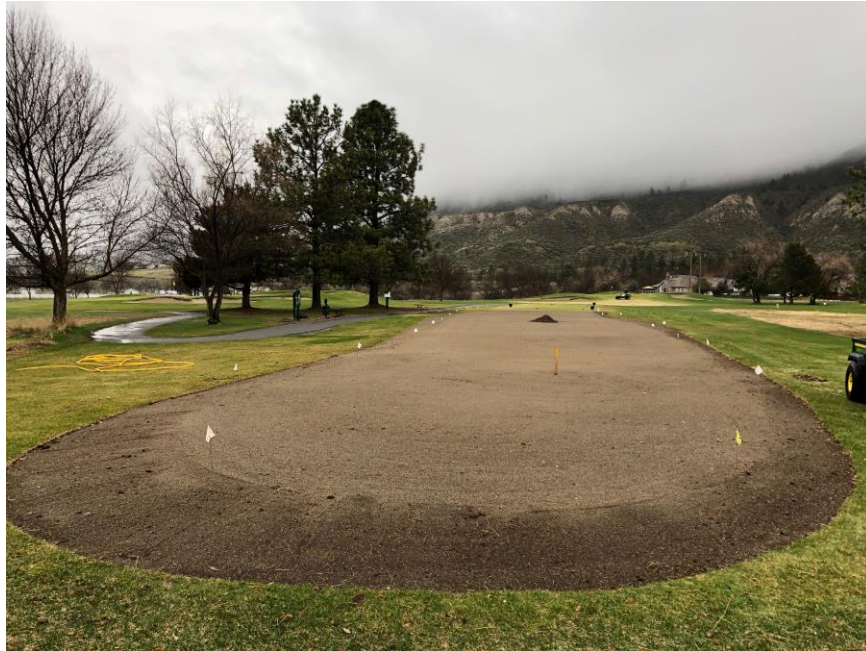
- The 2<sup>nd</sup> tee has been leveled and the surrounds prepared for sod. Once the irrigation sprinklers are leveled to the new grade we will fertilize and seed the teeing surface. Immediately following the seeding of the tee deck, we will install bluegrass sod in the surrounds.

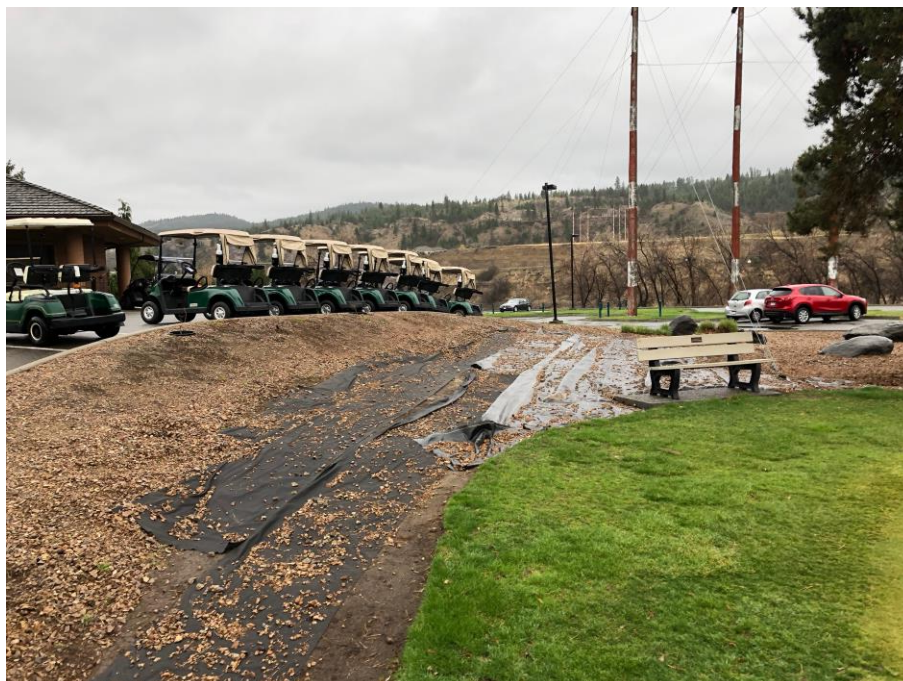
- The rock in front of the pro shop has been prepared to have new Arizona shale installed. The area where we removed turf last fall was cleaned up and covered with a layer of landscape fabric to inhibit weed growth. We are now just waiting for the producer to prepare some product and deliver it.

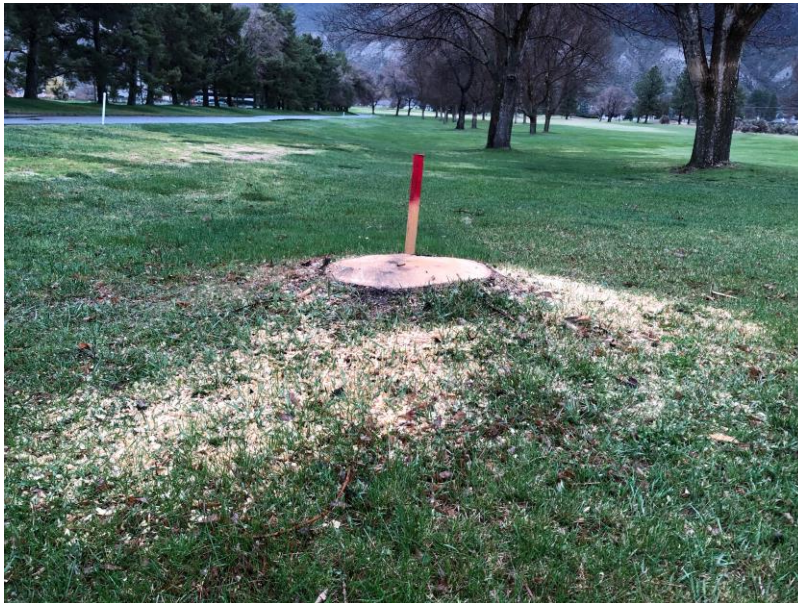
- Any taller stumps that were left from tree removals have been cut down as low as possible in preparation to be ground out.
